**Flood Control Project Maintenance
Levee Inspections**

Maintenance Issue Types Only, Levee Inspection Report By Mile - Spring 2019

Reclamation District No. 0307 Lisbon

Waterway	Bank	Unit Miles	Inspection Start/End	Inspector
Unit No. 01 Sacramento River	Right	6.56	03/08/2019 03/08/2019	Luz Dial

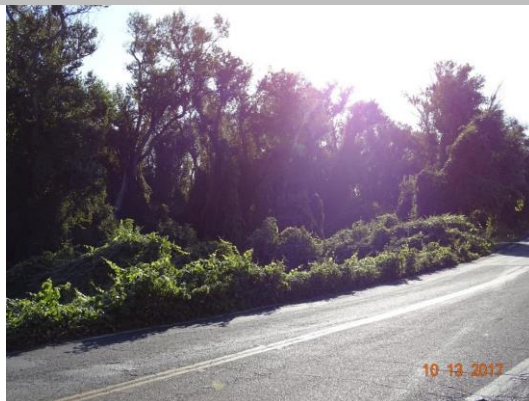
Photo 1 of 1 : SP_2019_RD0307_166_60_20190307_00014.jpg

Waterside vegetation should be trimmed to 20 feet from crown to allow inspection. Fall 2017

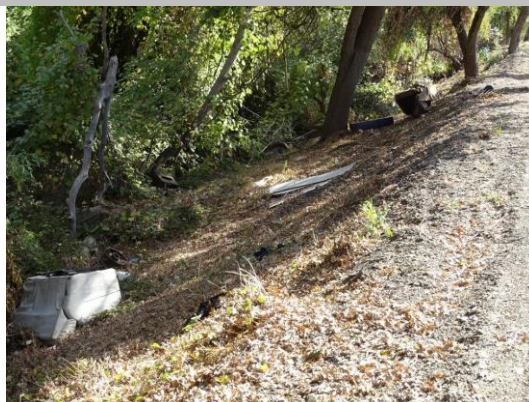
Photo 1 of 2 : SP_2019_RD0307_166_129_20190307_00039.jpg

LM Start	0.14	Rating **	M	Issue No.	129
LM End	0.14	Issue Type +	Ma	Location *	WS
Category	Earthen Levee			GPS Latitude/Longitude	
				Start	End
Item	Encroachments			38.478536 °	38.478536 °
				-121.547707 °	-121.547707 °
DWR ID	DWR_RD0307_01_f_2018_129				
Comment Code					
DE : Debris					
Inspector Comment					
Remove trash from slope.

View of sofa thrown on slope. Fall 2018

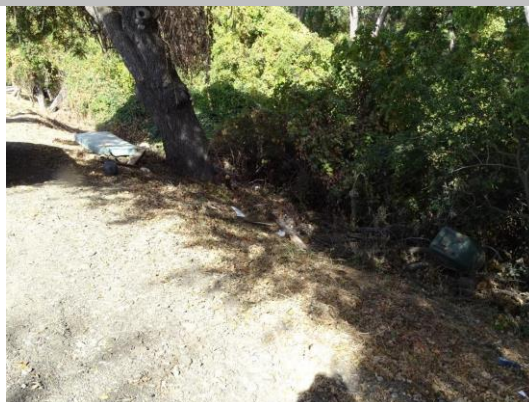
Photo 2 of 2 : SP_2019_RD0307_166_129_20190307_00040.jpg

View of mattress and other debris on slope. Fall 2018

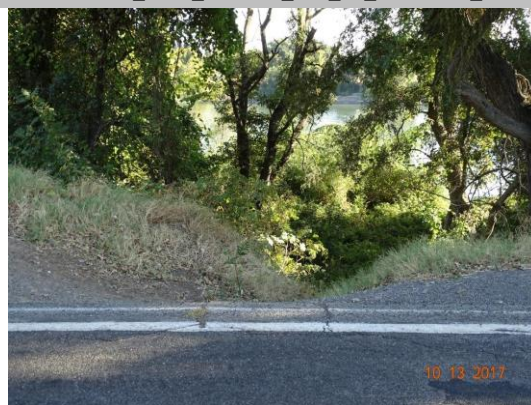
Photo 1 of 1 : SP_2019_RD0307_166_66_20190307_00016.jpg

LM Start	0.20	Rating **	M	Issue No.	66
LM End	0.20	Issue Type +	Ma	Location *	WS
Category	Earthen Levee			GPS Latitude/Longitude	
				Start	End
Item	Slope Stability			38.477977 °	38.477977 °
				-121.546914 °	-121.546914 °
DWR ID	DWR_RD0307_01_f_2017_66				
Comment Code					
S2 : Repair the levee slope damaged by foot traffic and prevent access where possible.					
Inspector Comment					
Foot traffic on waterside slope.

Slope erosion should be repaired and foot traffic stopped. Fall 2017

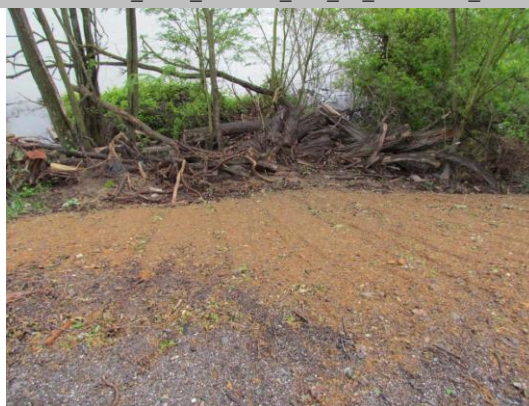
Photo 1 of 1 : SP_2019_RD0307_166_62_20190307_00015.jpg

RD 307 Levee mile 0.35 water side levee slope fallen cut up tree branches and tree sections placed at levee toe.

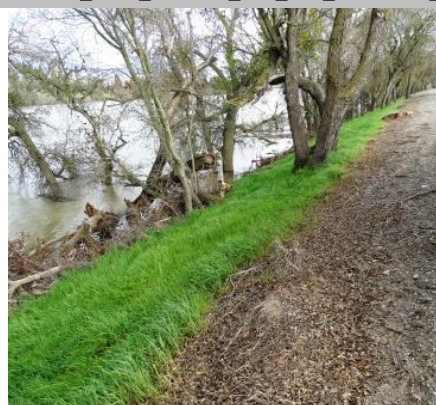
Photo 1 of 1 : SP_2019_RD0307_166_159_20190312_00136.jpg

LM Start	0.55	Rating **	M	Issue No.	159
LM End	0.55	Issue Type +	Ma	Location *	WS
Category	Earthen Levee			GPS Latitude/Longitude	
				Start	End
Item	Encroachments			38.474753 °	38.474753 °
				-121.541970 °	-121.541970 °
DWR ID	DWR_RD0307_01_s_2019_159				
Comment Code					
TR : Tree or limb					
Inspector Comment					
Fallen tree needs to be removed from levee slope.

View of fallen tree on levee slope. Spring 2019

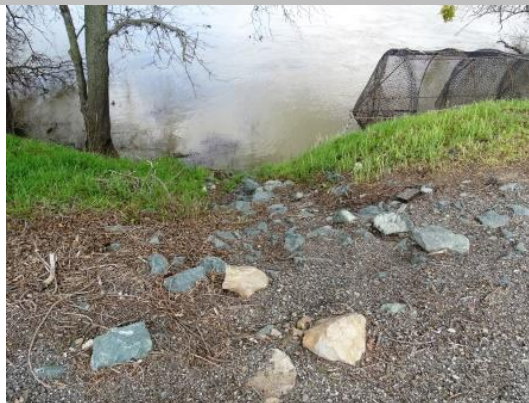
Photo 1 of 1 : SP_2019_RD0307_166_44_20190312_00135.jpg

LM Start	1.14	Rating **	M	Issue No.	44
LM End	1.23	Issue Type +	Ma	Location *	WS
Category	Supplemental			GPS Latitude/Longitude	
				Start	End
Item	2017 USACE Erosion Survey, DRAFT			38.473161 °	38.473103 °
				-121.531474 °	-121.529831 °
DWR ID	DWR_RD0307_01_s_2019_44				
Comment Code					
Inspector Comment					
2017 Site ID: SAC 48.6 R					
Status: Eroding					
2017 Field Notes: Site lengthened upstream and shortened downstream.					
Site History: 2012 - Bank is slowly eroding, old rock protection starting to unravel. 2016 - Anthropogenic erosion observed.					
2019 DWR Spring Inspection: Riprap placed on worst location.

View of revetment on worst location of erosion. Spring 2019

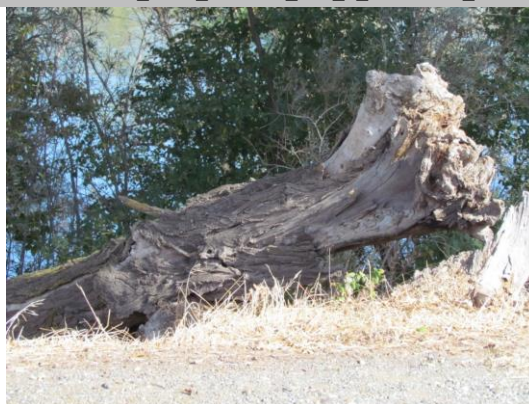
Photo 1 of 1 : SP_2019_RD0307_166_9_20190307_00001.jpg

LM Start	1.29	Rating **	U	Issue No.	9
LM End	1.29	Issue Type +	Ma	Location *	WS
Category	Earthen Levee			GPS Latitude/Longitude	
				Start	End
Item	Encroachments			38.472827 °	38.472827 °
				-121.528785 °	-121.528785 °
DWR ID	DWR_RD0307_01_f_2014_9				
Comment Code					
TR : Tree or limb					
Inspector Comment					
Remove fallen trees from waterside slope.

This tree needs to be removed from the waterside slope. Fall 2018

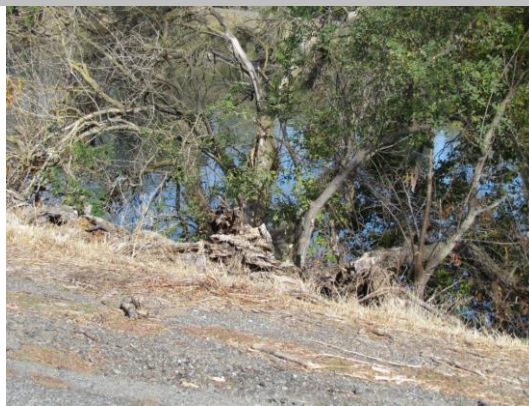
Photo 1 of 1 : SP_2019_RD0307_166_10_20190307_00002.jpg

Remove unwanted trees from waterside slope. These trees are dead and are resting on the slope. No change 4-17.

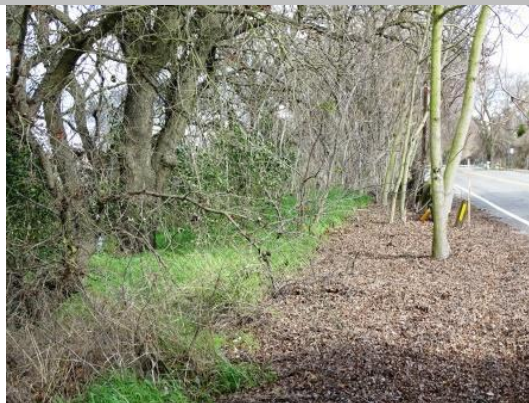
Photo 1 of 1 : SP_2019_RD0307_166_151_20190312_00134.jpg

View of dense trees/brush on levee slope. Spring 2019

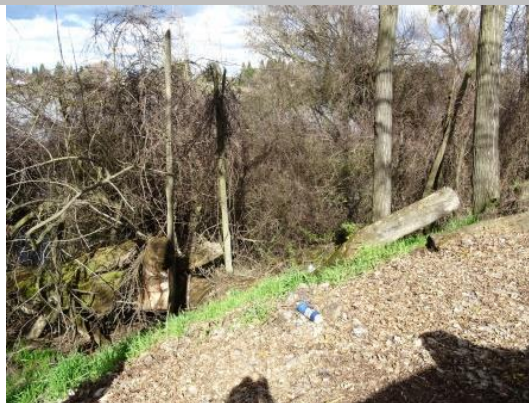
Photo 1 of 1 : SP_2019_RD0307_166_150_20190312_00133.jpg

View of fallen tree on levee slope. Spring 2019

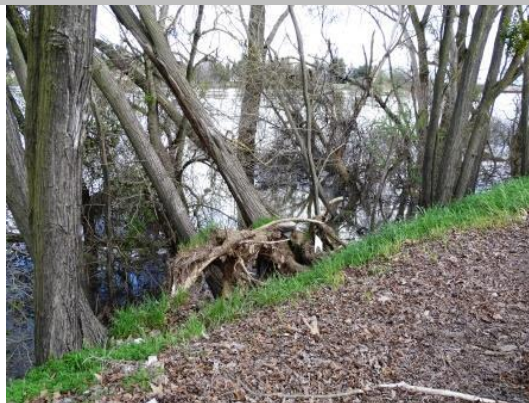
Photo 1 of 1 : SP_2019_RD0307_166_147_20190312_00132.jpg

View of fallen tree with exposed rootball. Spring 2019

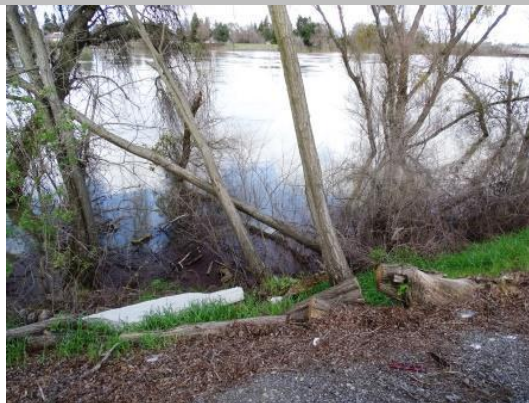
Photo 1 of 1 : SP_2019_RD0307_166_105_20190312_00137.jpg

View of mattress and tree log debris on waterside slope. Spring 2019

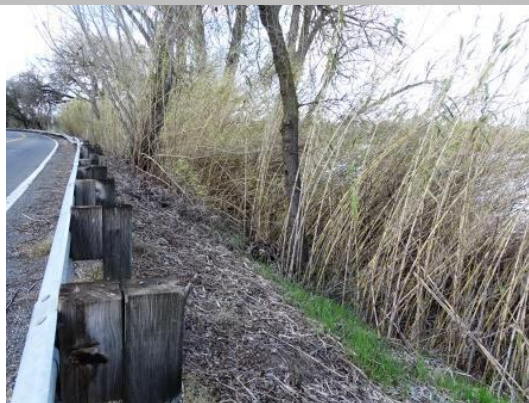
Photo 1 of 1 : SP_2019_RD0307_166_88_20190312_00131.jpg

View of Arundo on levee slope. Spring 2019

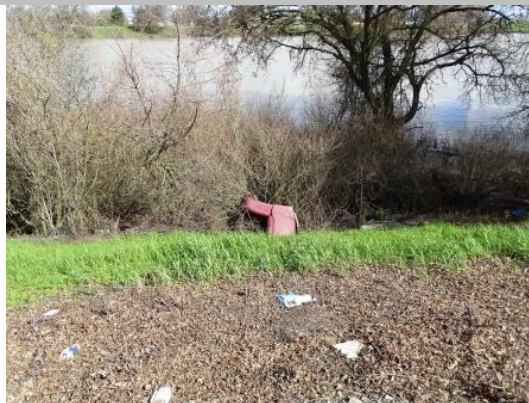
Photo 1 of 2 : SP_2019_RD0307_166_145_20190312_00127.jpg

View of sofa dumped on levee slope. Spring 2019

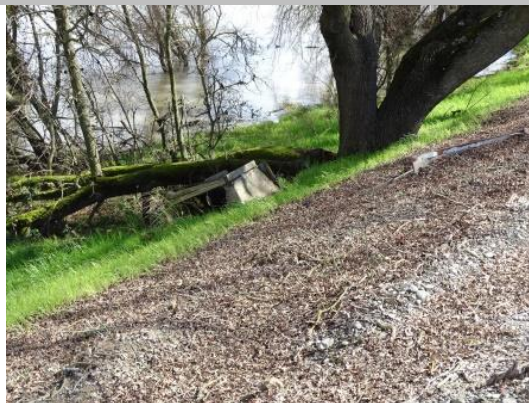
Photo 2 of 2 : SP_2019_RD0307_166_145_20190312_00128.jpg

View of fallen tree and debris on levee slope. Spring 2019

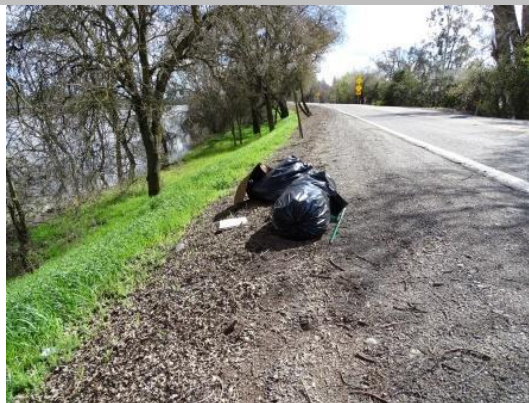
Photo 1 of 2 : SP_2019_RD0307_166_143_20190312_00125.jpg

View of trash dumped on levee slope. Spring 2019

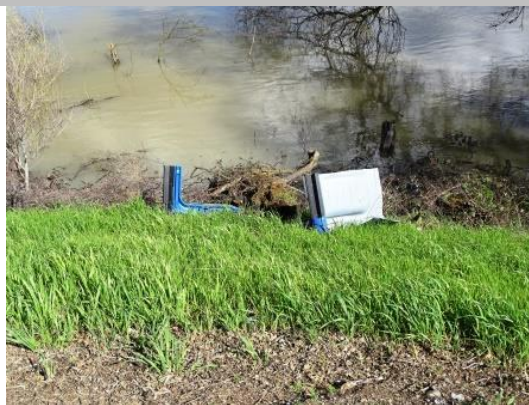
Photo 2 of 2 : SP_2019_RD0307_166_143_20190312_00126.jpg

View of auto debris on levee slope. Spring 2019

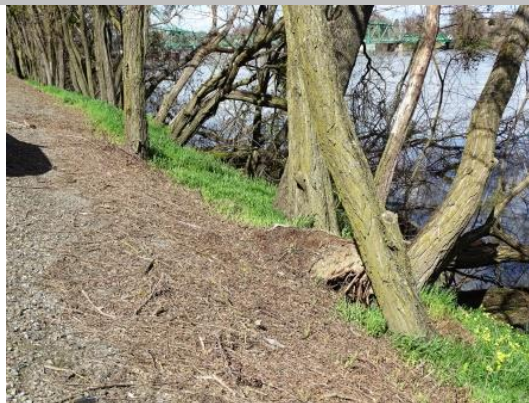
Photo 1 of 1 : SP_2019_RD0307_166_142_20190312_00124.jpg

View of fallen tree with rootball exposed. Spring 2019

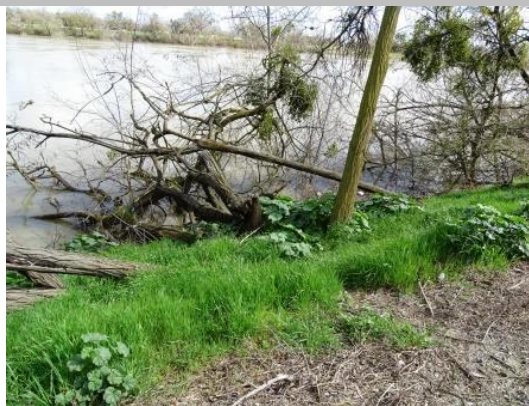
Photo 1 of 1 : SP_2019_RD0307_166_78_20190312_00123.jpg

LM Start	3.83	Rating **	M	Issue No.	78
LM End	3.83	Issue Type +	Ma	Location *	WS
Category	Earthen Levee			GPS Latitude/Longitude	
				Start	End
Item	Encroachments			38.451618 °	38.451618 °
				-121.502602 °	-121.502602 °
DWR ID	DWR_RD0307_01_s_2019_78				
Comment Code					
TR : Tree or limb					
Inspector Comment					
Fallen tree on levee slope needs to be cleared.

View of fallen tree on levee slope. Spring 2019

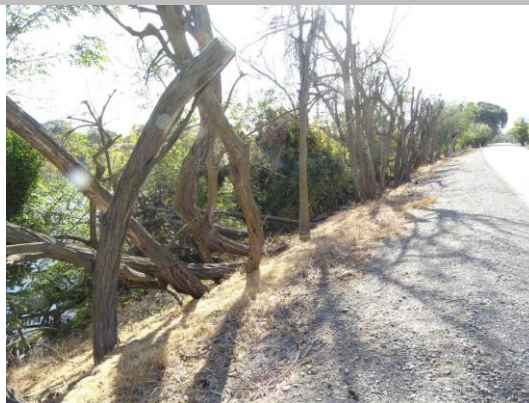
Photo 1 of 1 : SP_2019_RD0307_166_24_20190307_00004.jpg

LM Start	3.86	Rating **	M	Issue No.	24
LM End	3.86	Issue Type +	Ma	Location *	WS
Category	Earthen Levee			GPS Latitude/Longitude	
				Start	End
Item	Encroachments			38.451123 °	38.451123 °
				-121.502622 °	-121.502622 °
DWR ID	DWR_RD0307_01_f_2014_24				
Comment Code					
TR : Tree or limb					
Inspector Comment					
Remove the cut tree limbs from the waterside shoulder.

View of tree limbs on levee slope. Fall 2018

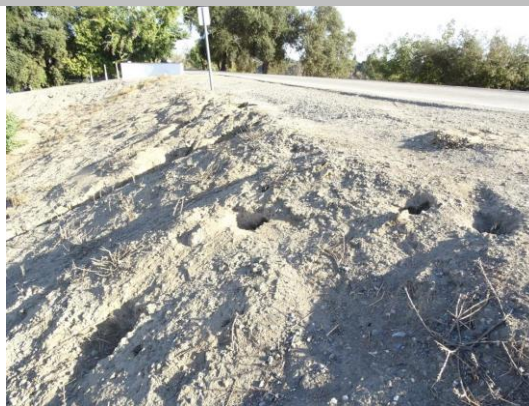
Photo 1 of 1 : SP_2019_RD0307_166_111_20190307_00033.jpg

View of rodent holes on landside slope. Fall 2018

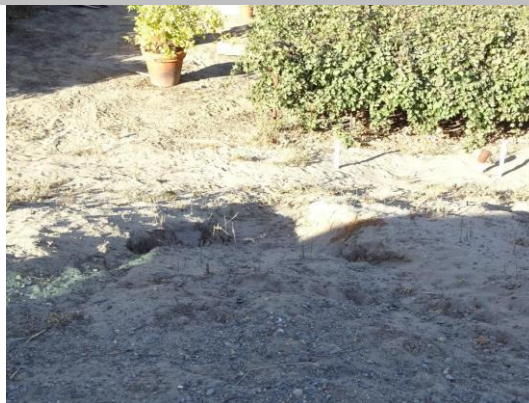
Photo 1 of 3 : SP_2019_RD0307_166_128_20190307_00036.jpg

LM Start	3.98	Rating **	M	Issue No.	128
LM End	3.98	Issue Type +	Ma	Location *	LS
Category	Earthen Levee			GPS Latitude/Longitude	
				Start	End
Item	Erosion / Bank Caving			38.449404 °	38.449404 °
				-121.502663 °	-121.502663 °
DWR ID	DWR_RD0307_01_s_2018_128				
Comment Code					
E1 : Note and monitor erosion site.					
Inspector Comment					
Repair rills on landside slope. Additionally, repair rodent holes along this stretch.

View of erosion on slope. Fall 2018

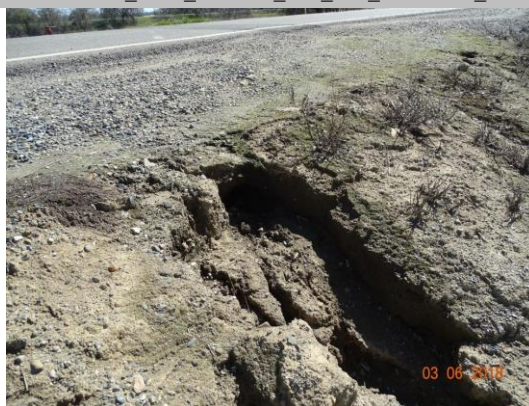
Photo 2 of 3 : SP_2019_RD0307_166_128_20190307_00037.jpg

LM Start	3.98	Rating **	M	Issue No.	128 (cont)	
LM End	3.98	Issue Type +	Ma	Location *	LS	
Category	Earthen Levee			GPS Latitude/Longitude		
				Start		End
Item	Erosion / Bank Caving			38.449404 °		38.449404 °
				-121.502663 °		-121.502663 °
DWR ID	DWR_RD0307_01_s_2018_128					
Comment Code						
E1 : Note and monitor erosion site.						
Inspector Comment						
Repair rills on landside slope. Additionally, repair rodent holes along this stretch.

Erosion rodent hole landside looking east. Spring 2018

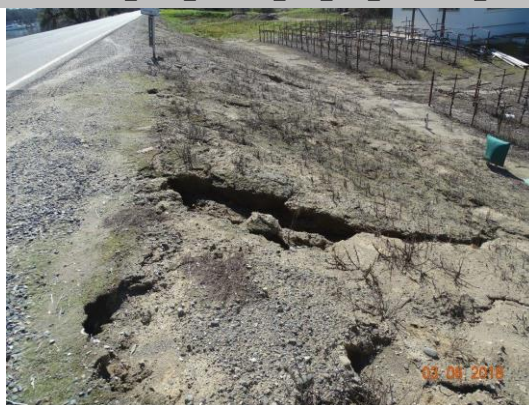
Photo 3 of 3 : SP_2019_RD0307_166_128_20190307_00038.jpg

Erosion rodent hole landside looking south. Spring 2018

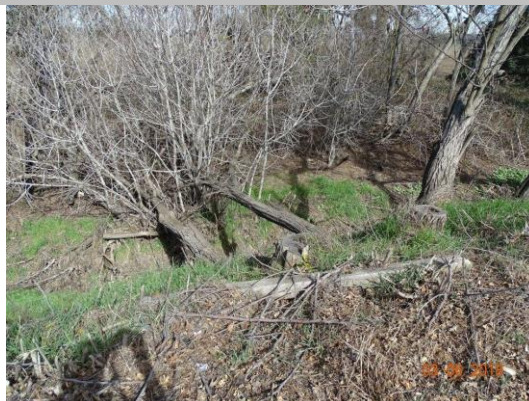
Photo 1 of 1 : SP_2019_RD0307_166_104_20190307_00029.jpg

View of fallen tree on landside slope. Spring 2018

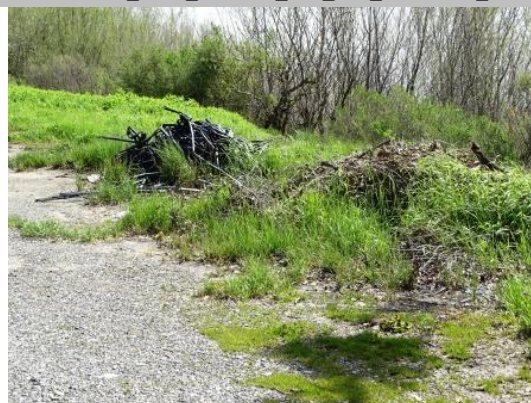
Photo 1 of 1 : SP_2019_RD0307_166_135_20190312_00122.jpg

View of landscaping debris and prunings dumped on waterside slope.
Spring 2019

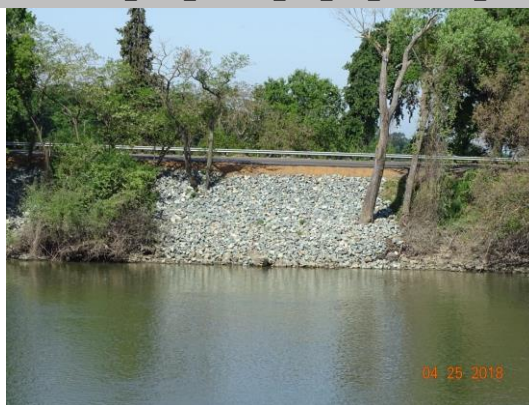
Photo 1 of 2 : SP_2019_RD0307_166_107_20190307_00030.jpg

LM Start	6.42	Rating **	A/W	Issue No.	107
LM End	6.55	Issue Type +	Ma	Location *	WS
Category	Earthen Levee			GPS Latitude/Longitude	
				Start	End
Item	Erosion / Bank Caving			38.431792 °	38.429923 °
				-121.533353 °	-121.533235 °
DWR ID	DWR_RD0307_01_s_2018_107				
Comment Code					
Inspector Comment					
This is to identify corrections to the USACE 2015 Erosion survey. The LMA repaired erosion sites in 2017. Spring 2019 DWR Inspection: Riprap and slope remain intact.

RD307 Lisbon Unit 1 Issue 107 LM6.42-6.55 Erosion repaired picture taken from LB looking west.

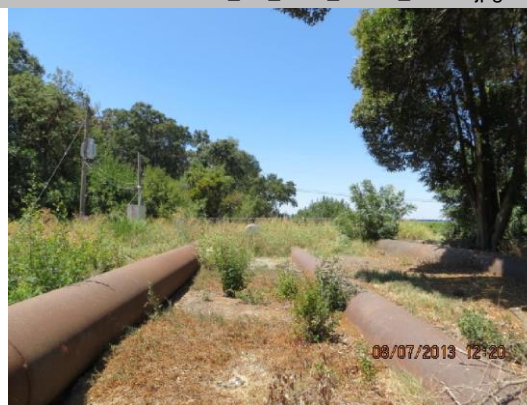
Photo 1 of 3 : UCIP_SP_2019_17406_29510.jpg

LM Start	6.54	Rating **	A/W	Issue No.	192
LM End	6.54	Issue Type +	Ma	Location *	
Category	Supplemental			GPS Latitude/Longitude	
				Start	End
Item	DWR UCIP LMA Responsibility			38.430043 °	38.430043 °
				-121.533275 °	-121.533275 °
DWR ID	21731				
Comment Code					
Inspector Comment					
FS_ID:17406					
DS_ID:21731					
EP_NO: N/A					
Repair Type: No Action Needed					
Crossing Status: Found					
UCIP Comments:					
FIELD_STRUCT_DESC: 2 of 2: 36-inch steel drainage pipe through the levee, 16 feet below the crown. Flap gate on the waterside (WS) end. Gate valve and air vent on the landside (LS). Pump and trash rack 200 feet off the LS toe. [Additional Reference(s): DWR Levee Log, 1990. USACE Sacramento O&M Manual 114, April 1959, (RM 43.08)].					
FS Date: 8/7/2013

Pipes visible on LS toe.

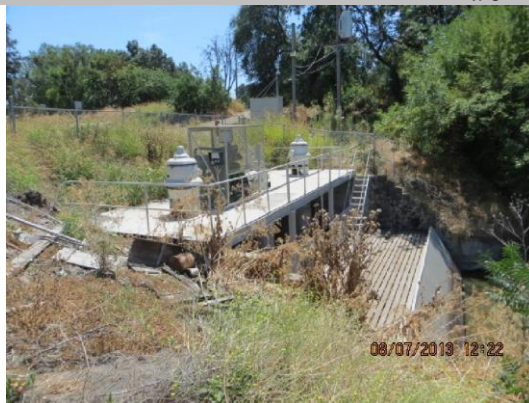
Photo 2 of 3 : UCIP_SP_2019_17406_29509.jpg

Pump and trash rack 200-feet off LS toe.

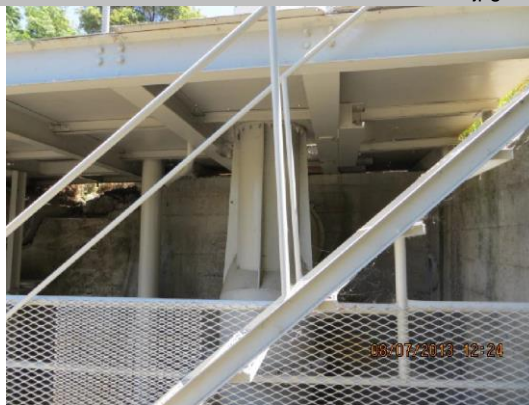
Photo 3 of 3 : UCIP_SP_2019_17406_29508.jpg

Intake at concrete headwall under pump.
